**THE JONES LIBRARY**  
**AMHERST, MASSACHUSETTS**  
**HISTORIC STRUCTURE REPORT**

**DRAFT 12-22-21**

Prepared for:  
The Town of Amherst  
Amherst, MA

DECEMBER 22, 2021

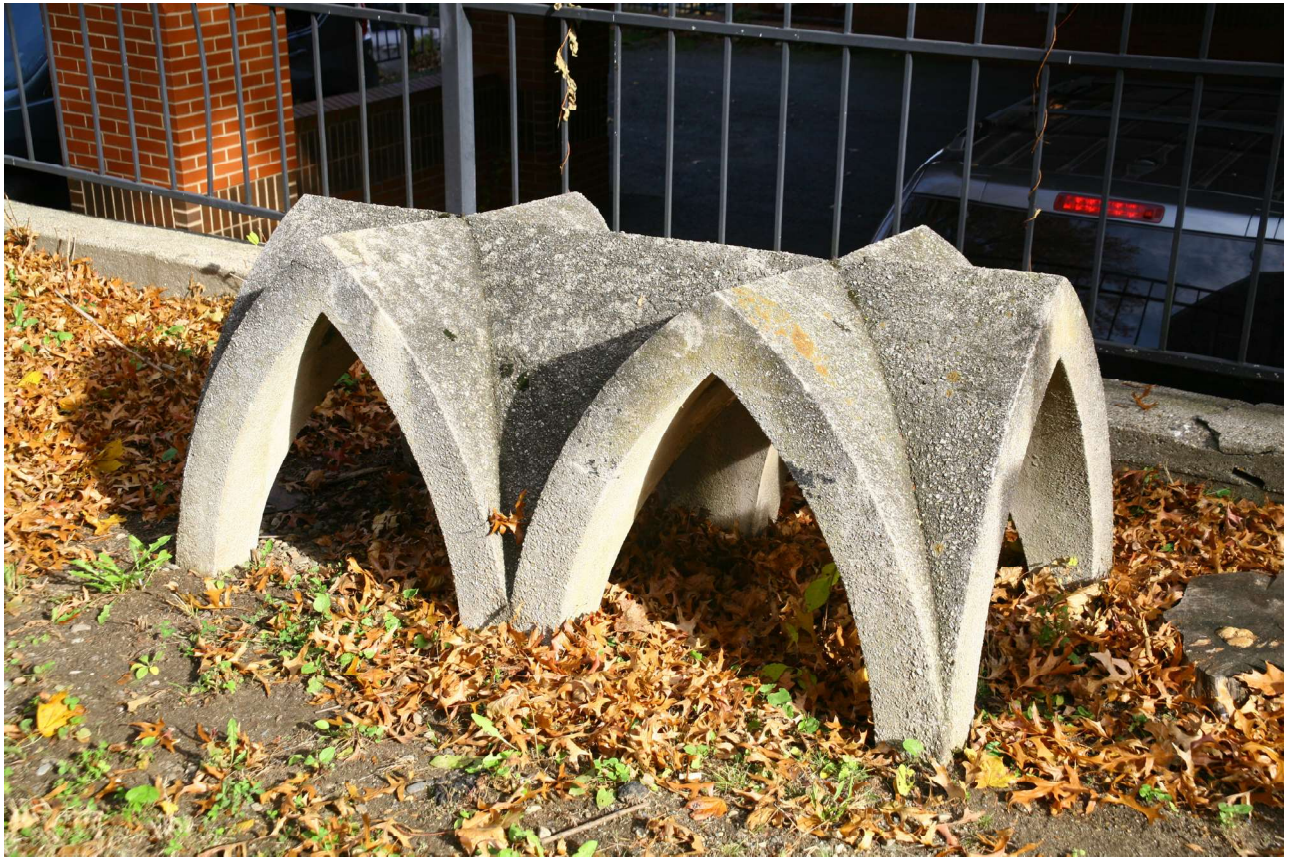
*Fig. 5612. An example of one of the original chimney caps used on the building. This piece was saved when new caps were installed on the chimneys.*

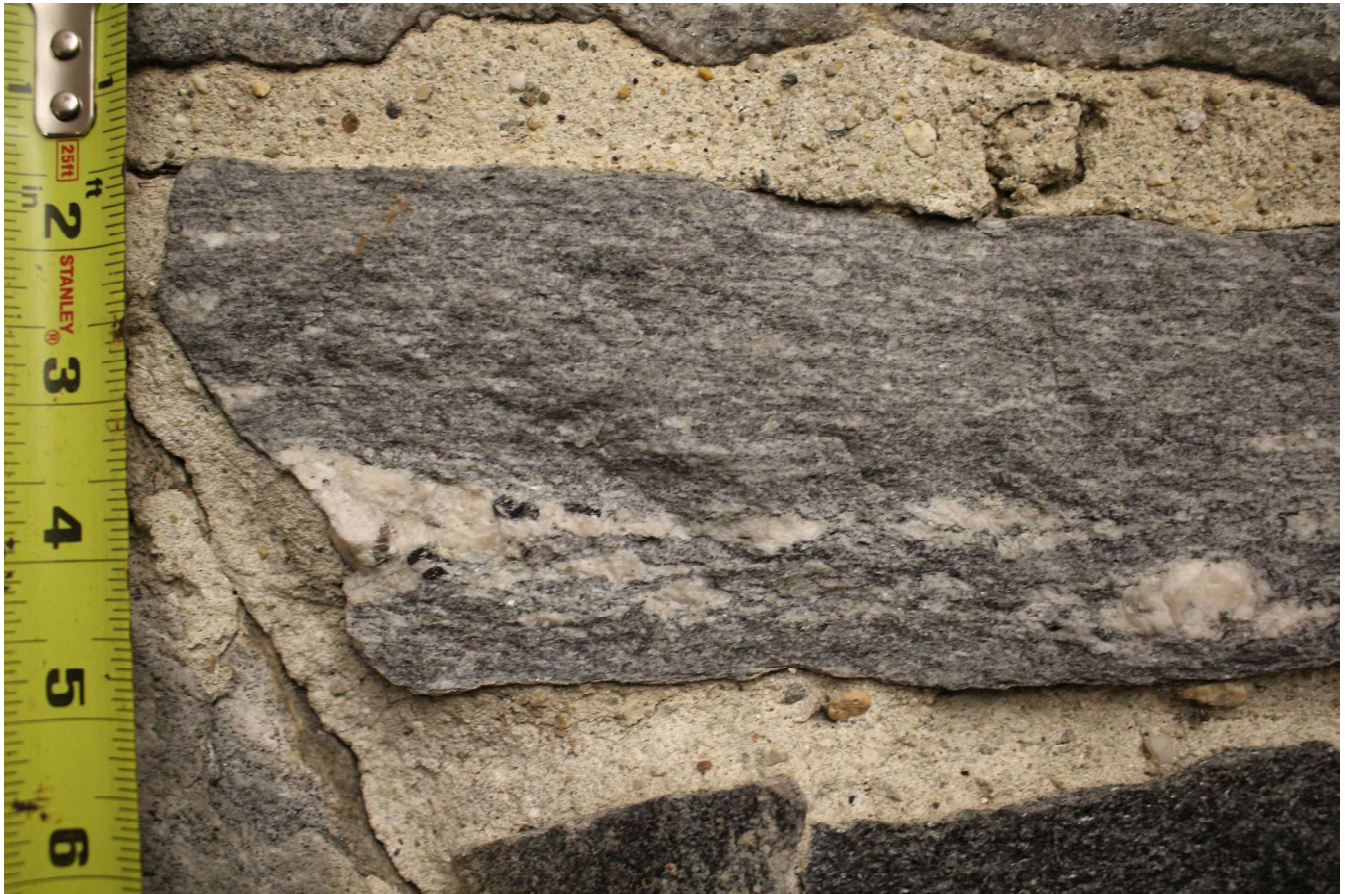
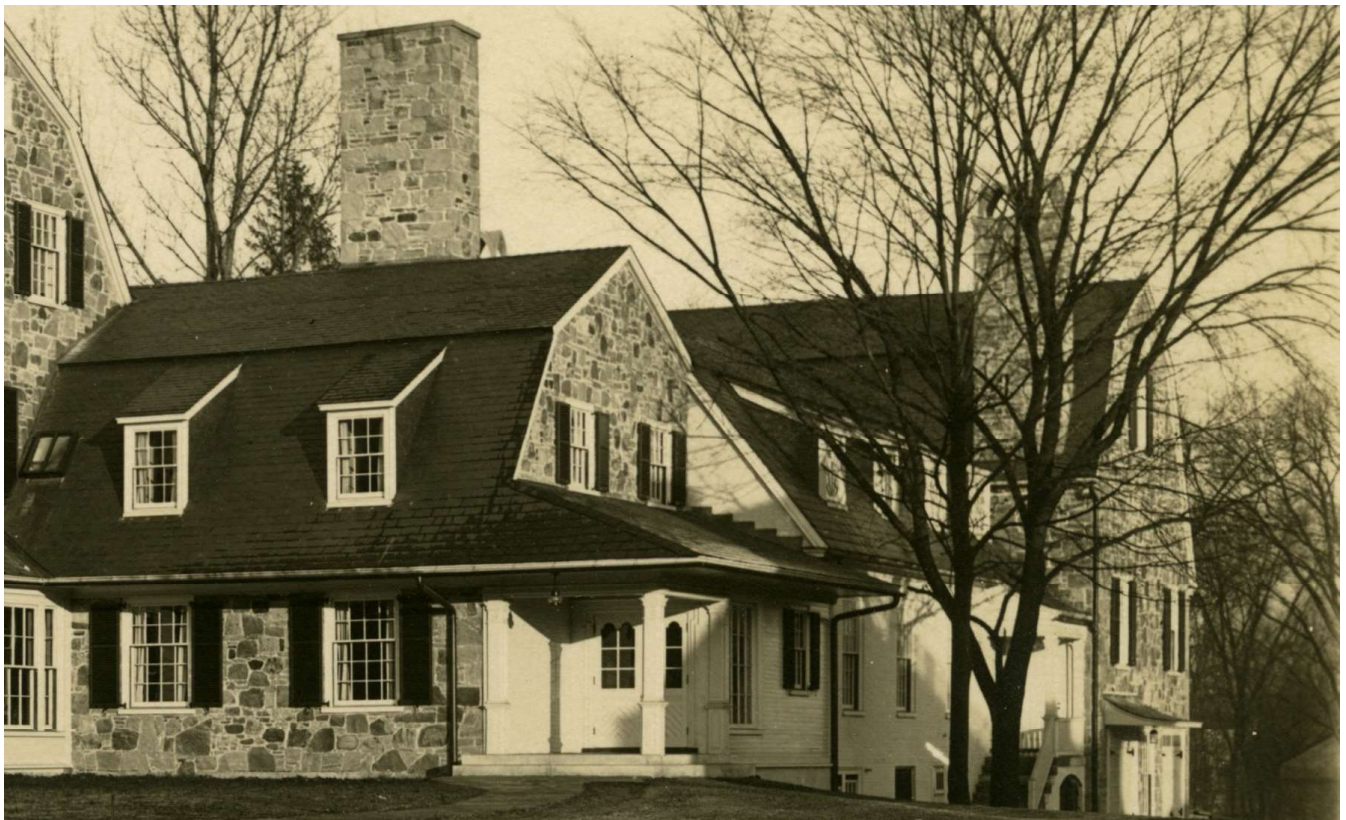
*Fig. 0089017\_crop. Detail of the east wing, circa 1928. Notice how the brickwork is painted. This would have presented a more finished appearance and tied the different portions of the wing together.*

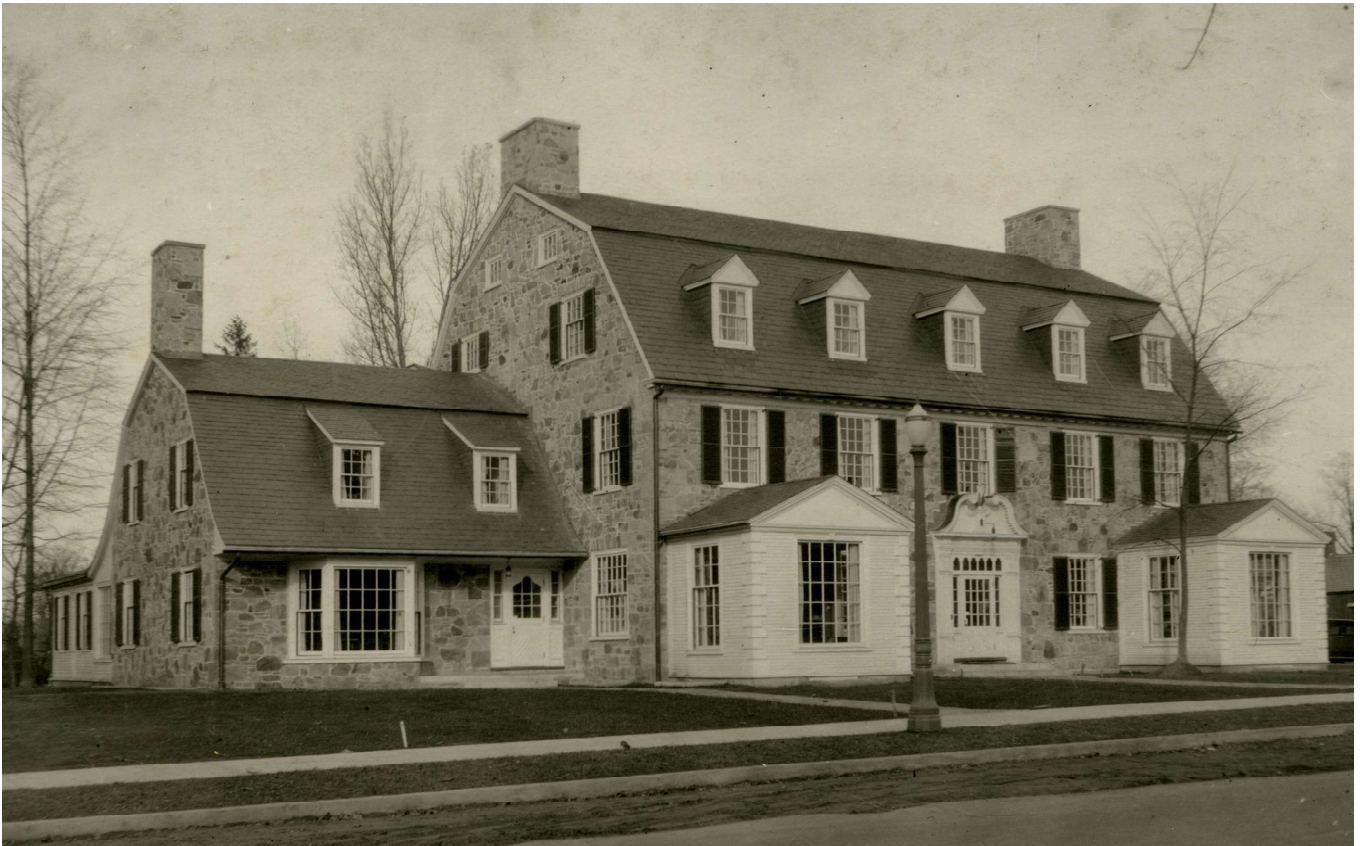
*Fig. Jones Library SW crop. Jone Library circa 1928. This historic view provides a good look at both Sun Porches which are now mostly hidden behind vegetation. The absence of perimeter plantings allows the stately nature of the architecture to show through.*

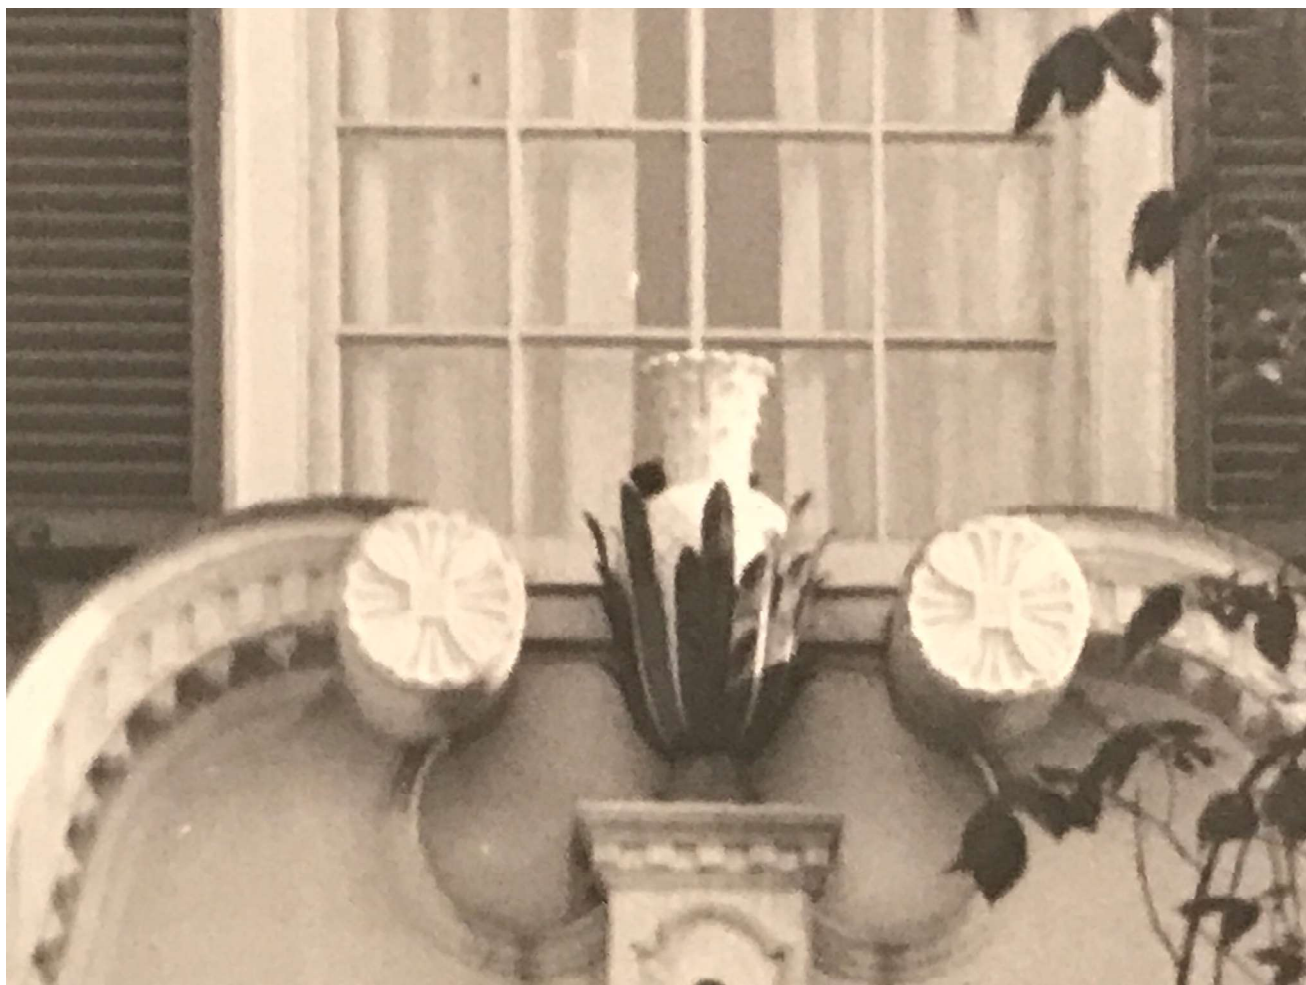
*Fig. 7867. Detail of the pineapple located in the pediment of the frontis. Note the leaves surrounding the body of the fruit. These may have been made from some type of sheet material, such as tin or copper, and gilded.*

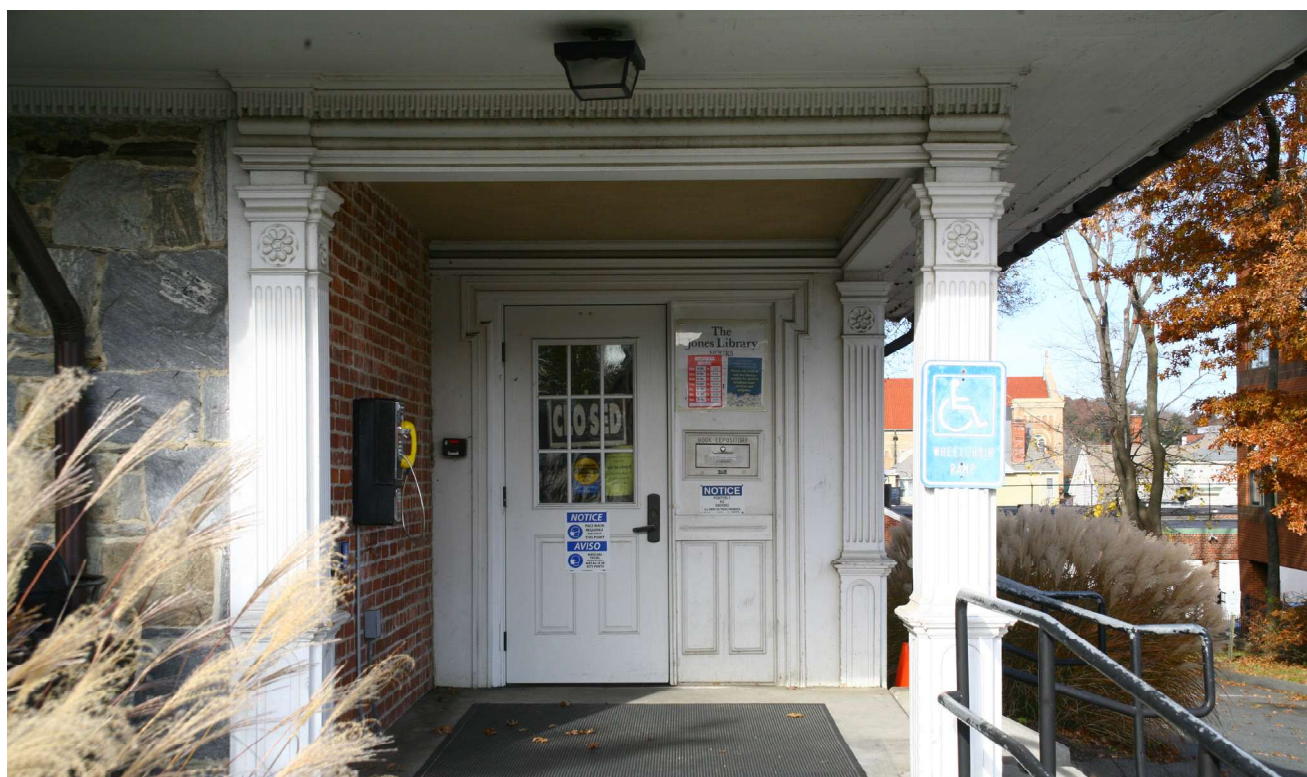
*Fig. 5492. East entry. The building is hidden behind a variety of different plantings that range in size and type. Vines should not be allowed to grow on wood surfaces. Large deciduous trees should be removed and kept well away from the perimeter of the building*

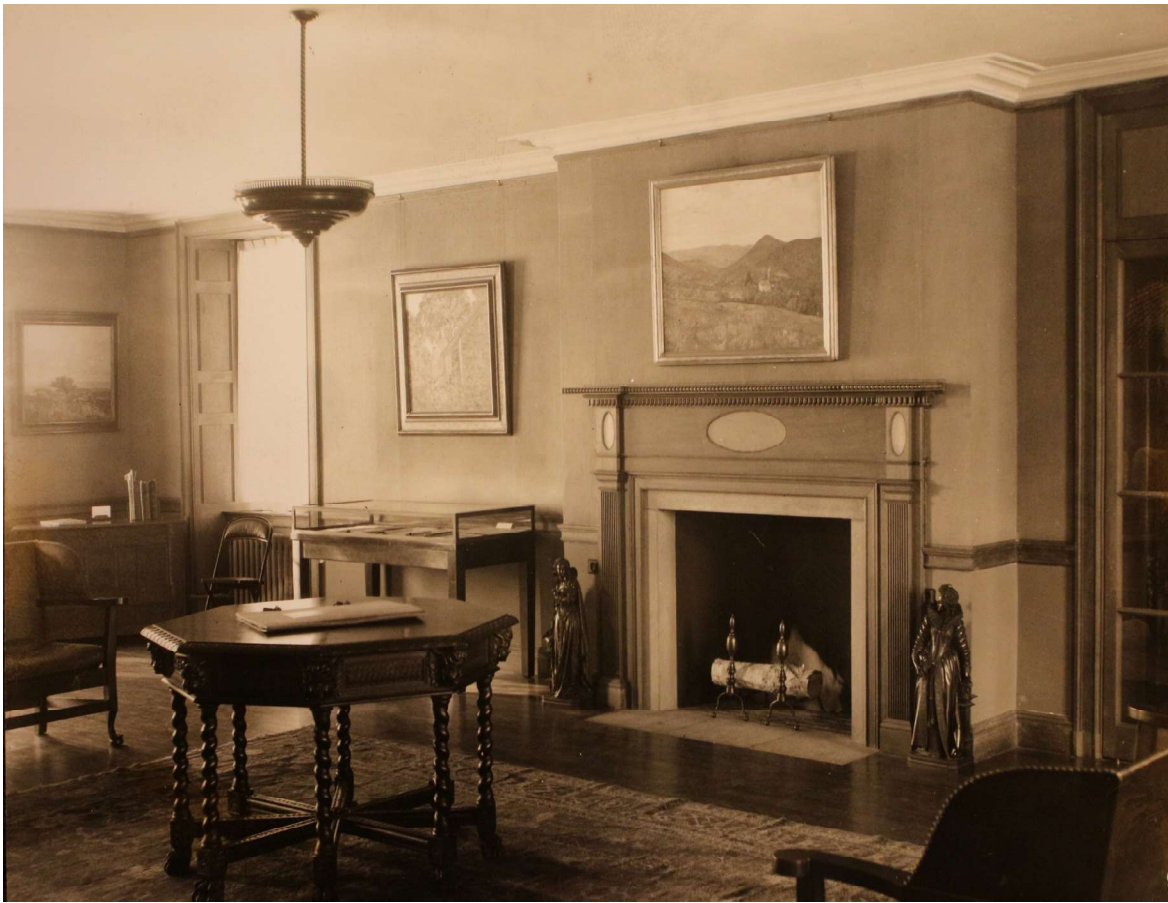
Historic photographs of the library's interior clearly show differences in surface treatments. Because these are black and white images, colors can not be discerned; however, it is clear that based on the white of ceilings, the walls of rooms are not only painted a different color, but that, in some locations, different colors were used above and below chair rails (Fig. 9091 +9086).

*Fig. 9091. Exhibition Room. This image taken in circa 1929 shows that the walls were painted in some type of color scheme. Note how the white of the cornice contrasts with the tone of the walls. This photo offers an excellent idea of how the rooms were furnished, as well as an example of the ceiling fixtures originally used in the building.*

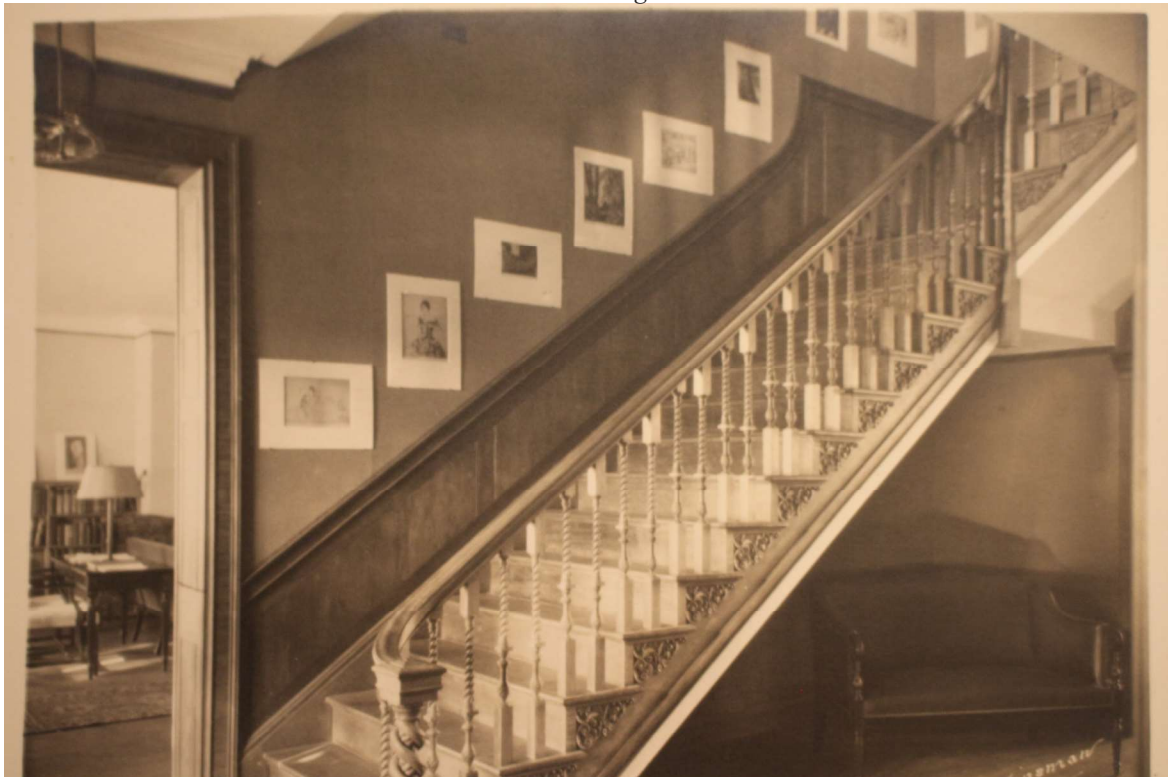
*Fig. 9086. Main stair hall, circa 1929. The dark tone of the walls indicated they were painted in a color other than the white seen on the ceiling. Note the treatments in the room beyond.*

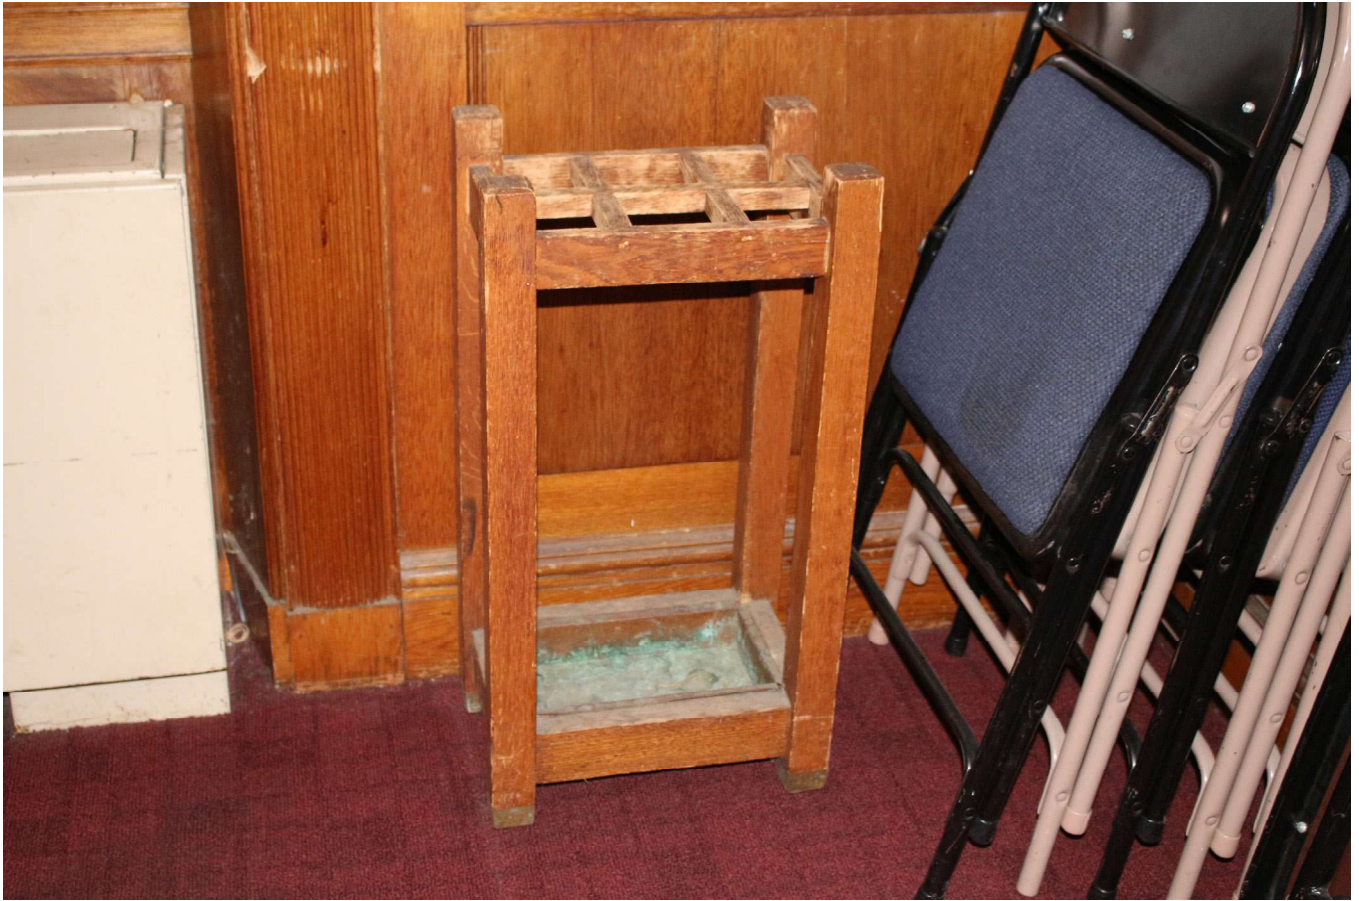
During the course of examining the library, it was surprising to find how many pieces of original and/or early furnishings and objects still remain throughout the building. These include reading tables, chairs, upholstered furniture and umbrella stands to andirons in fireplaces and the tall clock on the landing of the main staircase (Fig. 8697, 8716, 8802, 8804). A large number of items have been cataloged and are stored in The Trustees' Meeting Room and elsewhere by the Special Collections department; however, a variety of pieces are located throughout all parts of the library and still in use. Library staff appear to be aware of these pieces; it is uncertain if the full extent of what remains is known and if it has been cataloged in its entirety. While some pieces are labeled, such as tables and chairs in the Children's Reading room manufactured by Shaw Furniture Co., Cambridge, Mass., other pieces are not and might only be identified by a professional knowledgeable in furniture of this period. Much documentation exists in the library's Special Collections archive, and it may be possible to match many of these pieces with original invoices or inventories.

*Fig. 8697. One of two original, Arts and Crafts style, umbrella stands located in the building.*

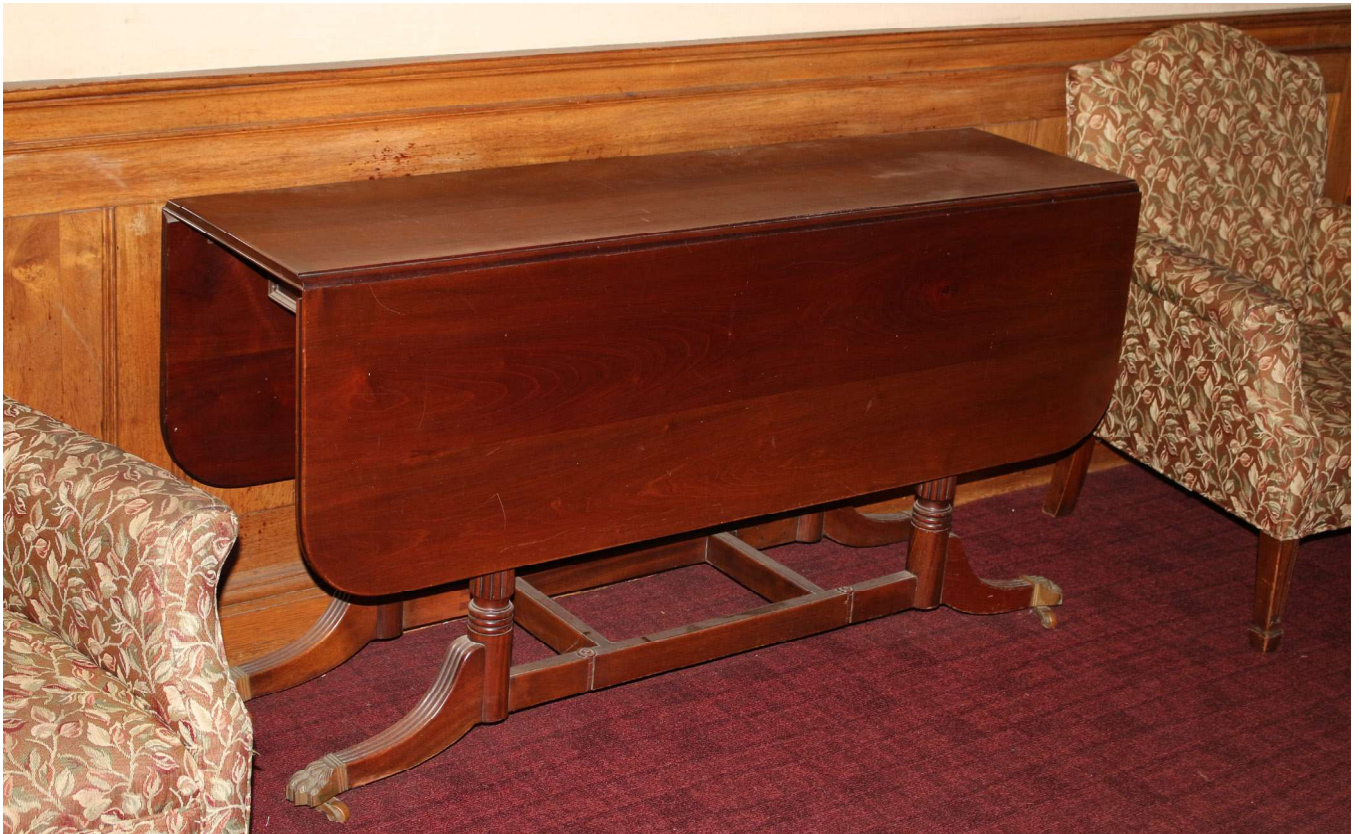
*Fig. 8716. Drop leaf table likely dating to the opening of the 1928 library*

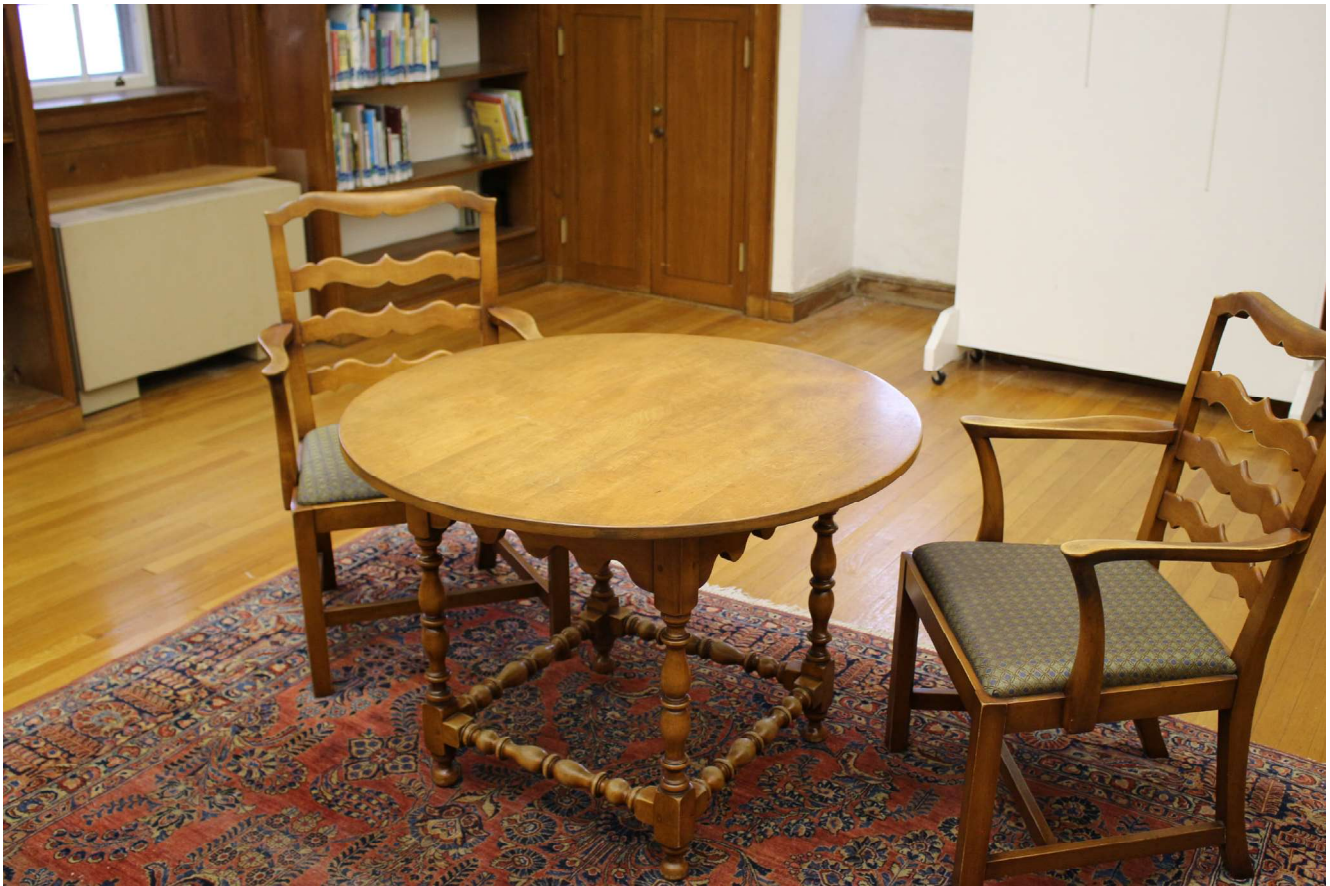
*Fig. 8802. Table and chair set labeled "Shaw Furniture Co. Cambridge, Mass." These date to the construction of the library and were part of its original furnishings.*

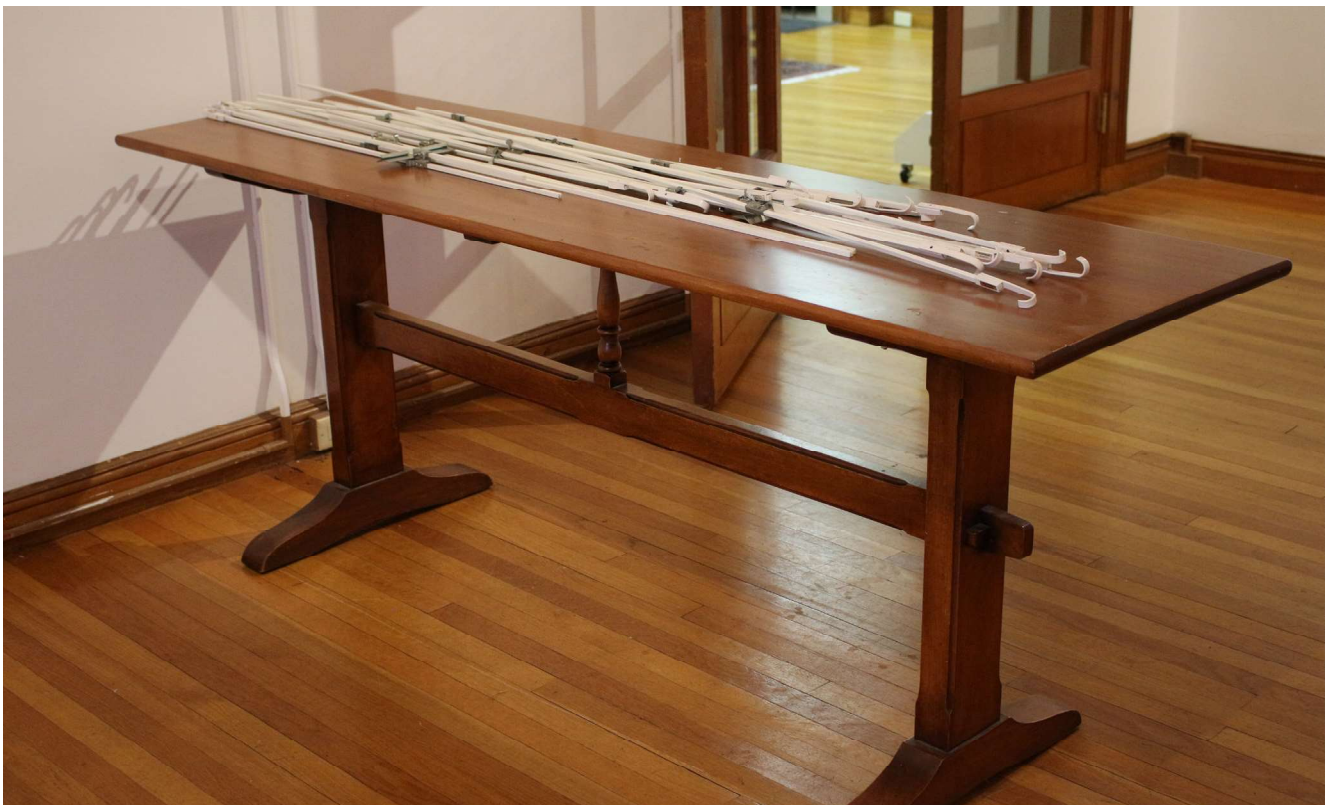
*Fig. 8804. Original trestle table still in use.*
